## New South Wales, Australia

**Date of issue:** 27 November 2020

**Work Area:** Operator and Assistant Platform for Steriline Hide Puller

**Incident Description:** An uncontrolled fall of the main cylinder supporting the carriage with Driver and Passenger platforms while not in production. The fall was from waist height (approximately 1m).

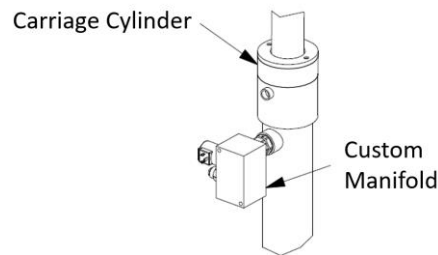
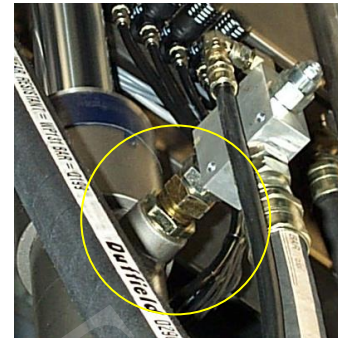
\* NOTE: assembly pictured is representative of the assembled Custom Manifold to Carriage Cylinder – appearance will vary according to age of the machine \*

- Immediate Action:**
- The cylinder was assessed for failure. The hydraulic connection fitting between the cylinder body and the counterbalance valve manifold had failed - **circled in yellow**.

- Initial Learnings:**
- The cylinder is prevented from falling by this counterbalance valve manifold block and rigid connection. This prevents a platform falling from a ruptured hydraulic hose. If the hydraulic connection fitting fails – the platform will fall.

- The failure mode for the hydraulic connection fitting is cracking and splaying of the swivel nut.
- Further Action:**
- Liaison with client investigation team and the OEM cylinder manufacturer.

- Steriline Hide Pullers have used this style of arrangement from very early machines (circa 1970's) and this may affect machines in service. Regular replacement of the hydraulic connection fitting is recommended.

- Immediate inspection of the coupling between the cylinder retract port and the custom manifold containing the counterbalance valve.
- Action by All Sites**

- Identify hydraulic cylinders in service to the Steriline Hide Puller – visually confirm the condition of the hydraulic connection fitting. Refer to Technical Bulletin **TB20-13** for more complete information before any intervention.

- Secure replacement hydraulic connection fittings to replace existing.
  - Implement an inspection program for this critical part of the cylinder deployed into rise and fall platform applications. Label the inspection and record it as a regular maintenance inspection within the Maintenance Management System (MMS).

- Typical cylinder life can be as much as 750,000 cycles before a rebuild is necessary. Replacing seals after 2 years is not uncommon. This is dependent on application, environment, and maintenance practices. As such a recommendation from Steriline is replace this hydraulic connection fitting every 2 years or at time of Carriage Cylinder replacement or refurbishment.
