Date of issue: 27 November 2020

Work Area: Operator and Assistant Platform for Steriline Hide Puller

Incident Description: An uncontrolled fall of the main cylinder supporting the carriage with Driver and Passenger platforms while not in production. The fall was from waist height (approximately 1m).

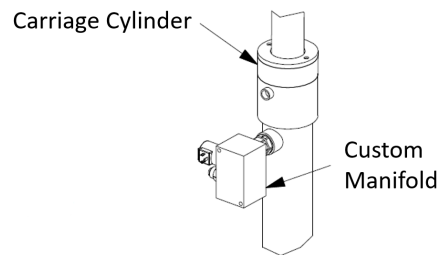
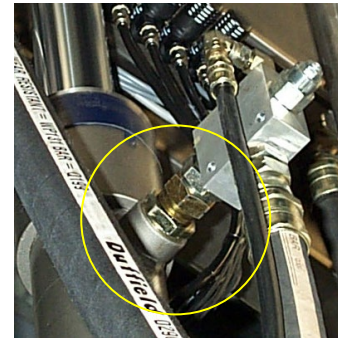
* NOTE: assembly pictured is representative of the assembled Custom Manifold to Carriage Cylinder – appearance will vary according to age of the machine

- Immediate Action:**
- The cylinder was assessed for failure. The hydraulic connection fitting between the cylinder body and the counterbalance valve manifold had failed - **circled in yellow** ○

- Initial Learnings:**
- The cylinder is prevented from falling by this counterbalance valve manifold block and rigid connection. This prevents a platform falling from a ruptured hydraulic hose. If the hydraulic connection fitting fails – the platform will fall.

- The failure mode for the hydraulic connection fitting is cracking and splaying of the swivel nut.
- Further Action:**
- Liaison with client investigation team and the OEM cylinder manufacturer.

- Immediate inspection of the coupling between the cylinder retract port and the custom manifold containing the counterbalance valve.
- Action by All Sites**

1. *Identify hydraulic cylinders in service to the Steriline Hide Puller – visually confirm the condition of the hydraulic connection fitting. Refer to Technical Bulletin **TB20-013** for more complete information before any intervention.*

2. *Secure replacement hydraulic connection fittings to replace existing.*
 3. *Implement an inspection program for this critical part of the cylinder deployed into rise and fall platform applications. Label the inspection and record it as a regular maintenance inspection within the Maintenance Management System (MMS).*

4. *Typical cylinder life can be as much as 750,000 cycles before a rebuild is necessary. Replacing seals after 2 years is not uncommon. This is dependent on application, environment, and maintenance practices. As such a recommendation from Steriline is replace this hydraulic connection fitting every 2 years or at time of Carriage Cylinder replacement or refurbishment.*
